# Manhole Inspection Summary

Manhole # S45UU\_026MH

**Location** Address: **2701 THE ALAMEDA**

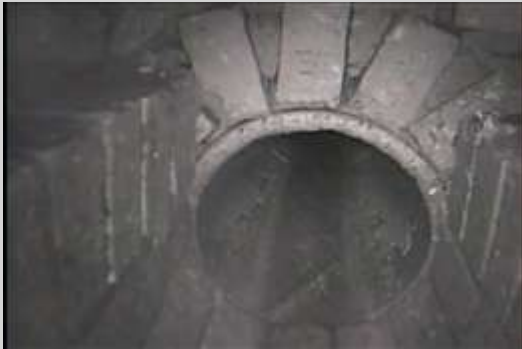
### 8 in. Circular Gravity Sewer Pipe Out @ 12 O'Clock

Rod and Bar (Angled)

Infiltration: **None** Pipe Seal Cond: **Unknown**
